# Hydrology Report

## White Cap Auto Spa Express Tunnel Car Wash

2000 N. Croatan HWY  
Kill Devil Hills, NC 27948

December 1, 2022  
Revised December 22, 2022

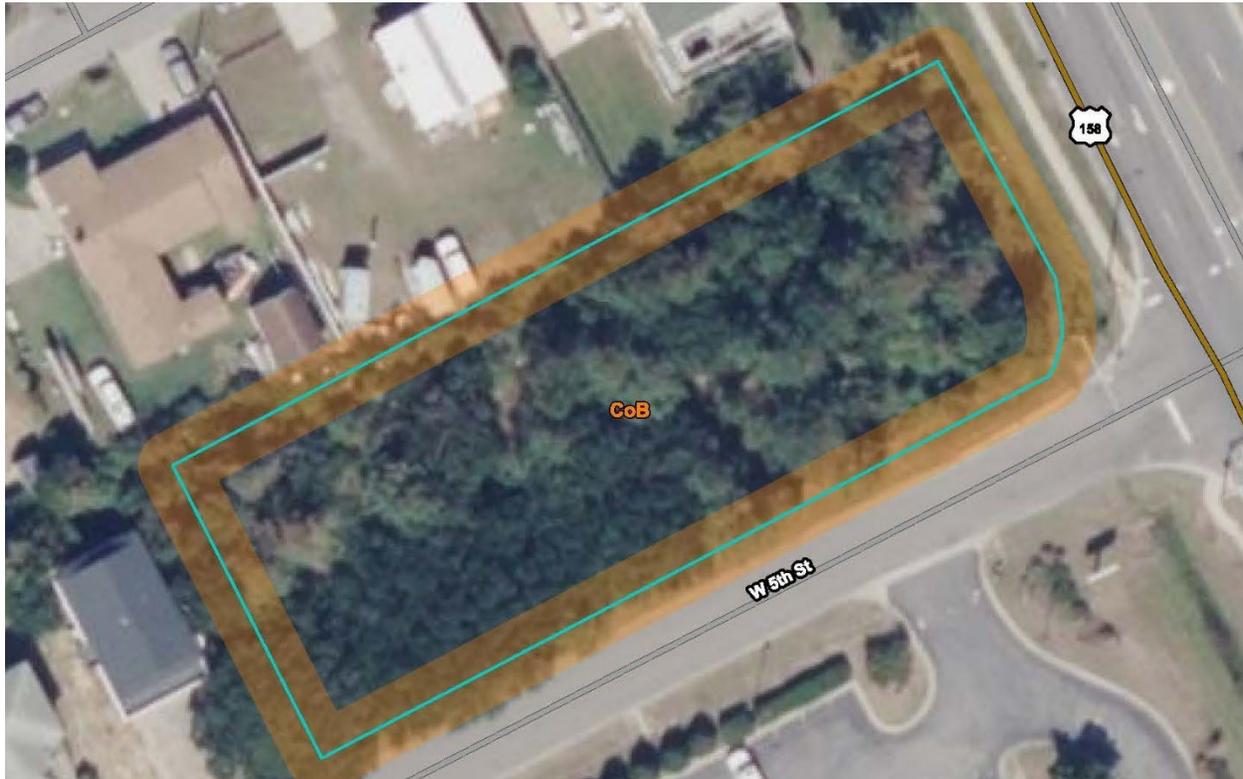
Existing soils on the site, as delineated by the National Cooperative Soil Survey of the U.S. Department of Agriculture and the Natural Resources Conservation Service are shown below.

Map Unit Symbol	Map Unit Name	Acres in AOI	Percent of AOI
CoB	Corolla fine sand, 0 to 6 percent slopes, rarely flooded	0.7	100.0%
<b>Totals for Area of Interest</b>		<b>0.7</b>	<b>100.0%</b>

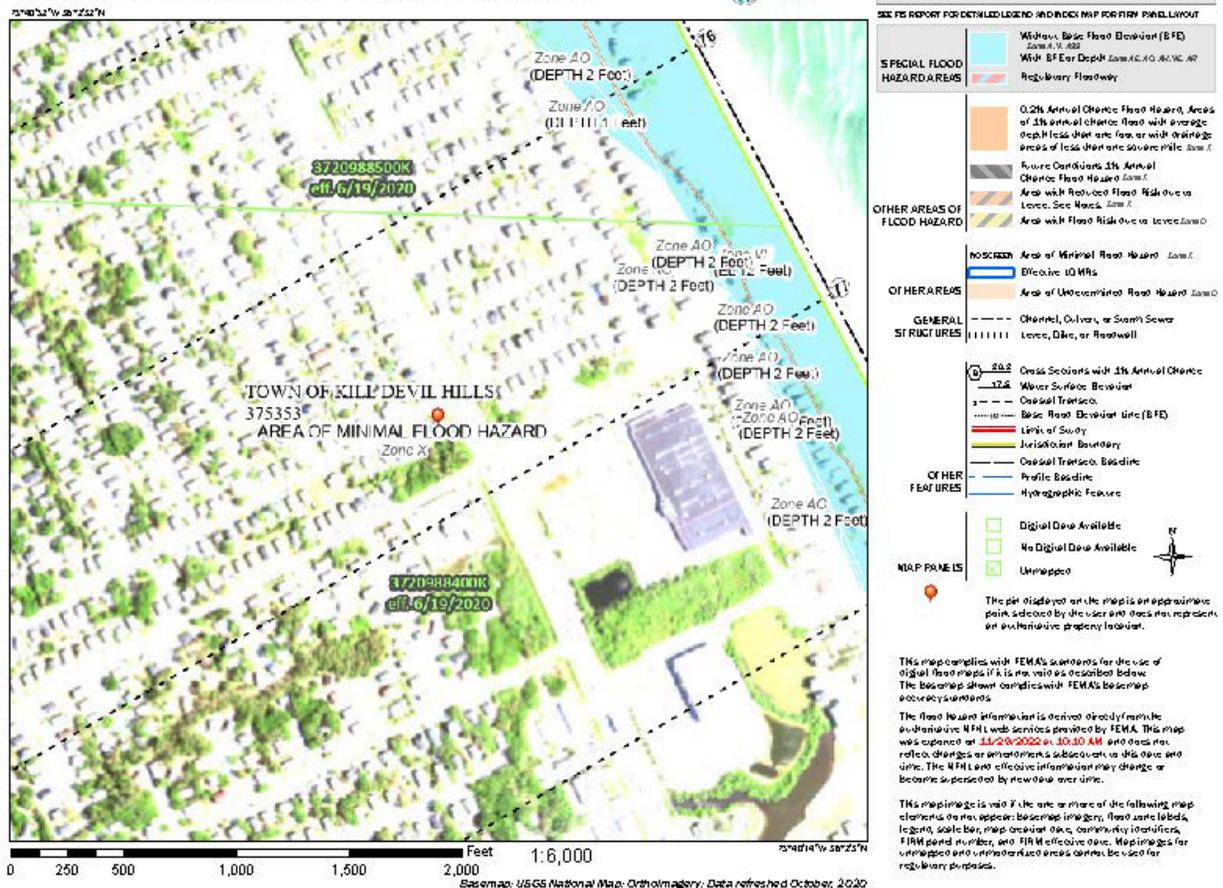
### National Flood Hazard Layer FIRMette

Per FIRM panel 3720988400K, effective date June 19, 2020, the site is not within a flood hazard area. This study examines the existing site condition of the 0.707-acre project area with the proposed site condition to ensure compliance with requirements of the Kill Devil Hills, NC Stormwater Management Ordinance.

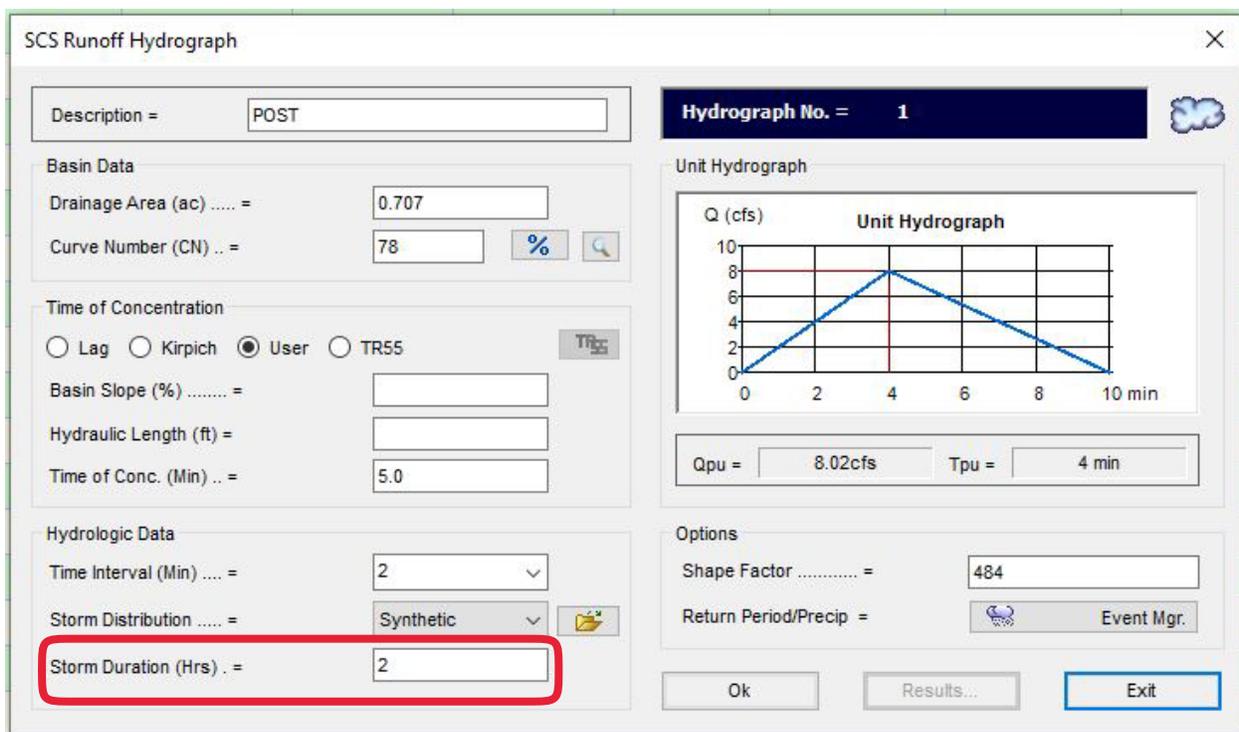
## HYDROGRAPH INPUT

The screenshot shows the 'SCS Runoff Hydrograph' software interface. The 'Description' field is set to 'POST'. The 'Basin Data' section includes a 'Drainage Area (ac)' of 0.707 and a 'Curve Number (CN)' of 78. The 'Time of Concentration' section has 'User' selected, with a 'Time of Conc. (Min)' of 5.0. The 'Hydrologic Data' section shows a 'Time Interval (Min)' of 2 and a 'Storm Duration (Hrs)' of 2, which is highlighted with a red box. The 'Options' section has a 'Shape Factor' of 484. On the right, the 'Unit Hydrograph' section displays a graph of discharge (Q in cfs) versus time (min), showing a triangular peak at 4 minutes with a maximum discharge of 8.02 cfs. Below the graph, 'Qpu' is 8.02cfs and 'Tpu' is 4 min.

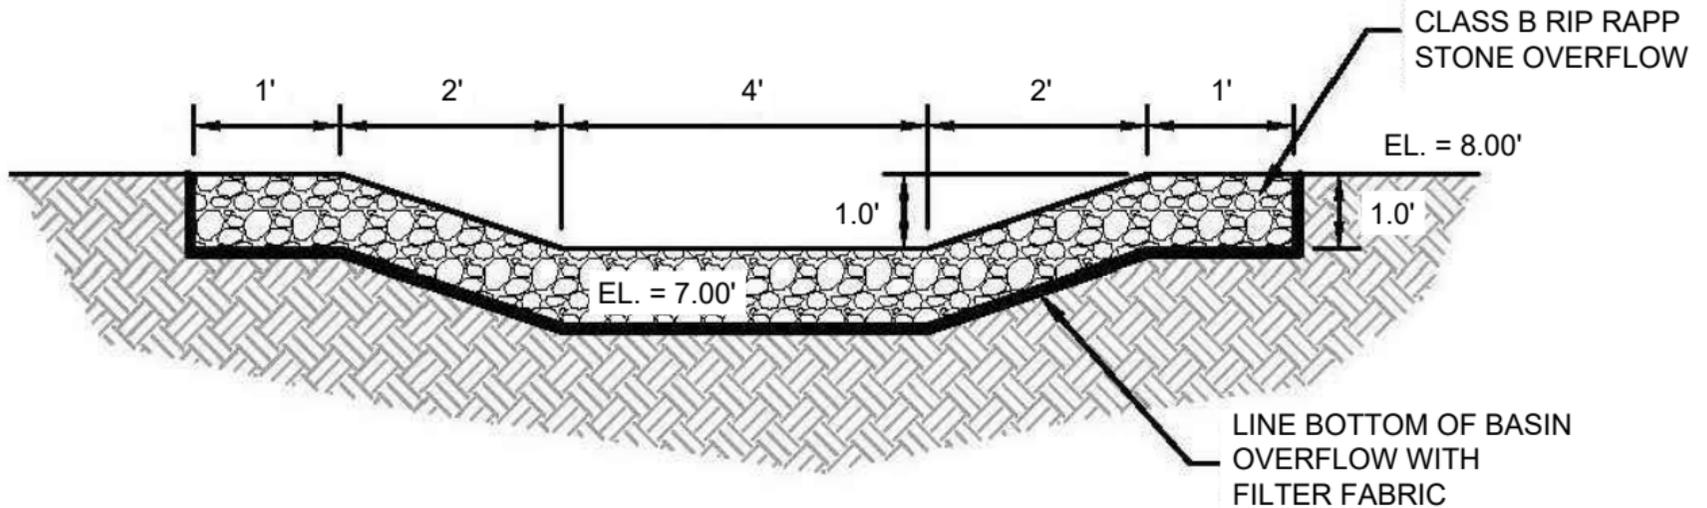
# BASIN OVERFLOW DETAIL

NOT TO SCALE

The increase in stormwater runoff from the site will be detained and infiltrate via the proposed Infiltration Basin. As shown in the Soil and Infiltration Test, see appendix, an infiltration rate of 20-in/hr was used during analysis. Said Infiltration Basin will control the 10-yr 2-hr storm event of 4.3" volume. Additional runoff will exit via the Basin Overflow, see appendix, which will be set at 7.00 feet.

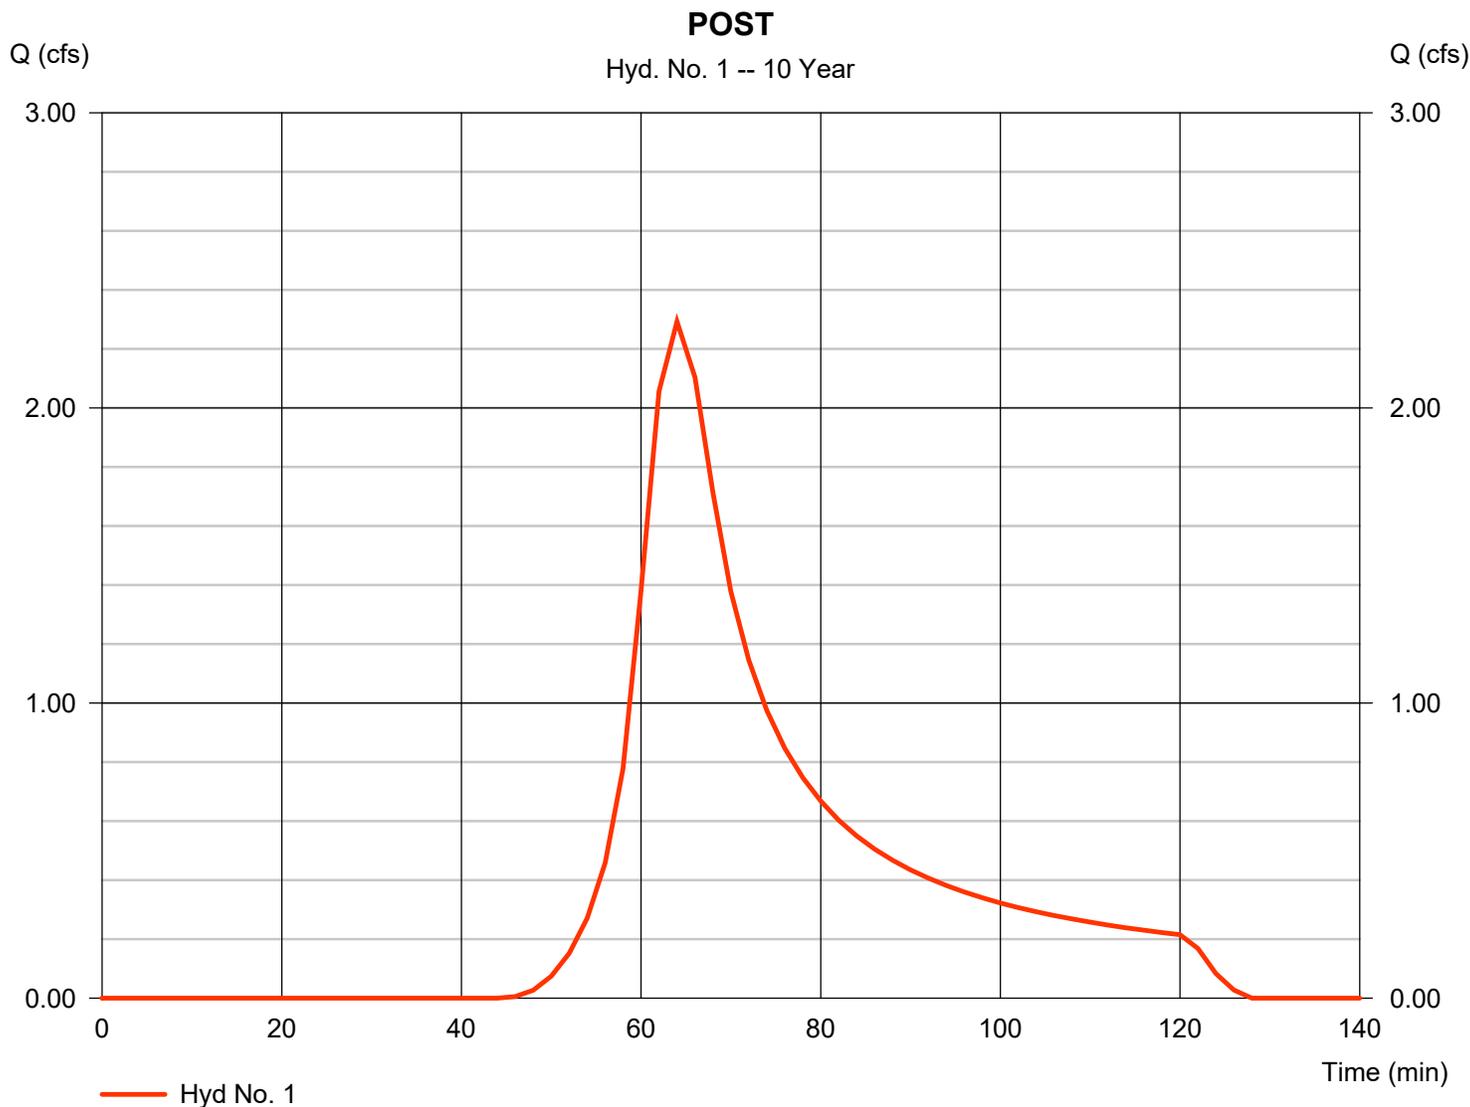
# Precipitation Report

### Incremental Rainfall Precipitation

Hyd. No. 1 : POST - 10 Year

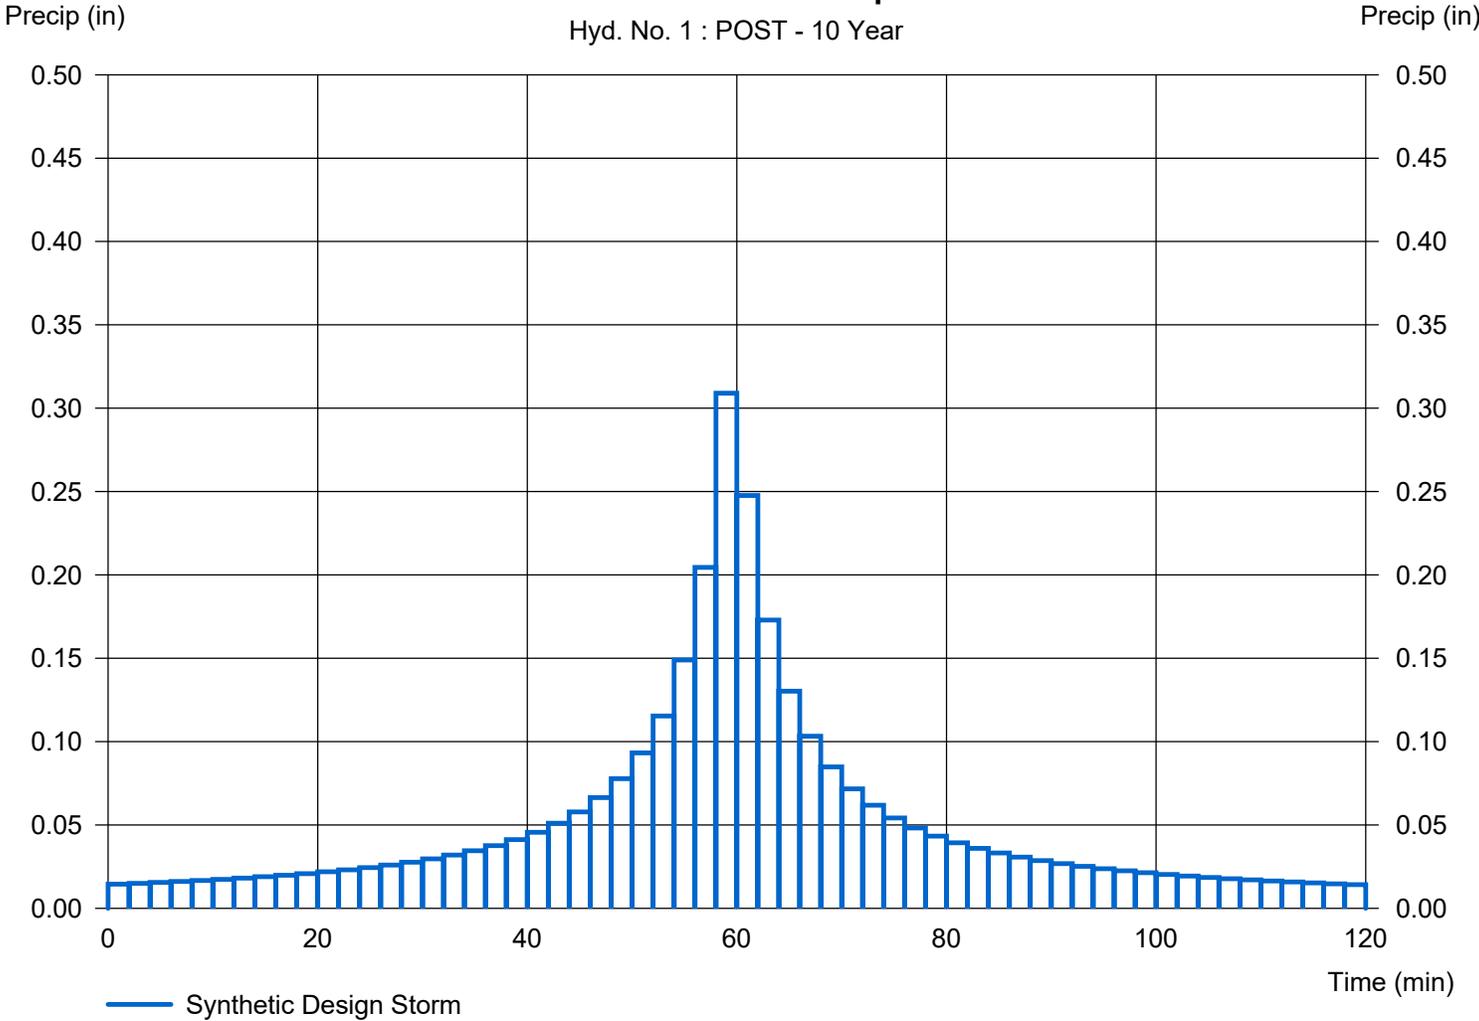
# Hydrograph Report

Hydrograph type	= Reservoir	Peak discharge	= 0.000 cfs
Storm frequency	= 10 yrs	Time to peak	= 152 min
Time interval	= 2 min	Hyd. volume	= 0 cuft
Inflow hyd. No.	= 1 - POST	Max. Elevation	= 6.29 ft
Reservoir name	= BASIN	Max. Storage	= 1,324 cuft

Storage Indication method used. Exfiltration extracted from Outflow.

SUMMARY OF BASIN PERFORMANCE			
STORM EVENT	ELEVATION (ft)	MAX. STORAGE (ft <sup>3</sup> )	MAX. DISCHARGE (ft <sup>3</sup> /sec)
10 YR	6.29	1,324	0.00

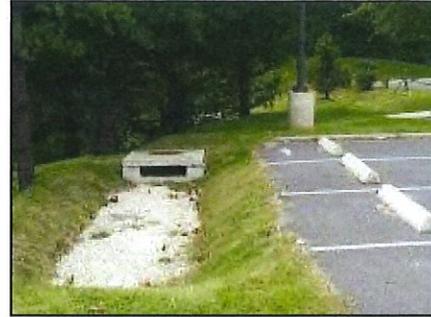
## Infiltration Practice

An infiltration practice is a shallow excavation, typically filled with stone or an engineered soil mix, which is designed to temporarily hold stormwater runoff until it infiltrates into the surrounding soils. Infiltration practices are able to reduce stormwater quantity, recharge the groundwater, and reduce pollutant loads.

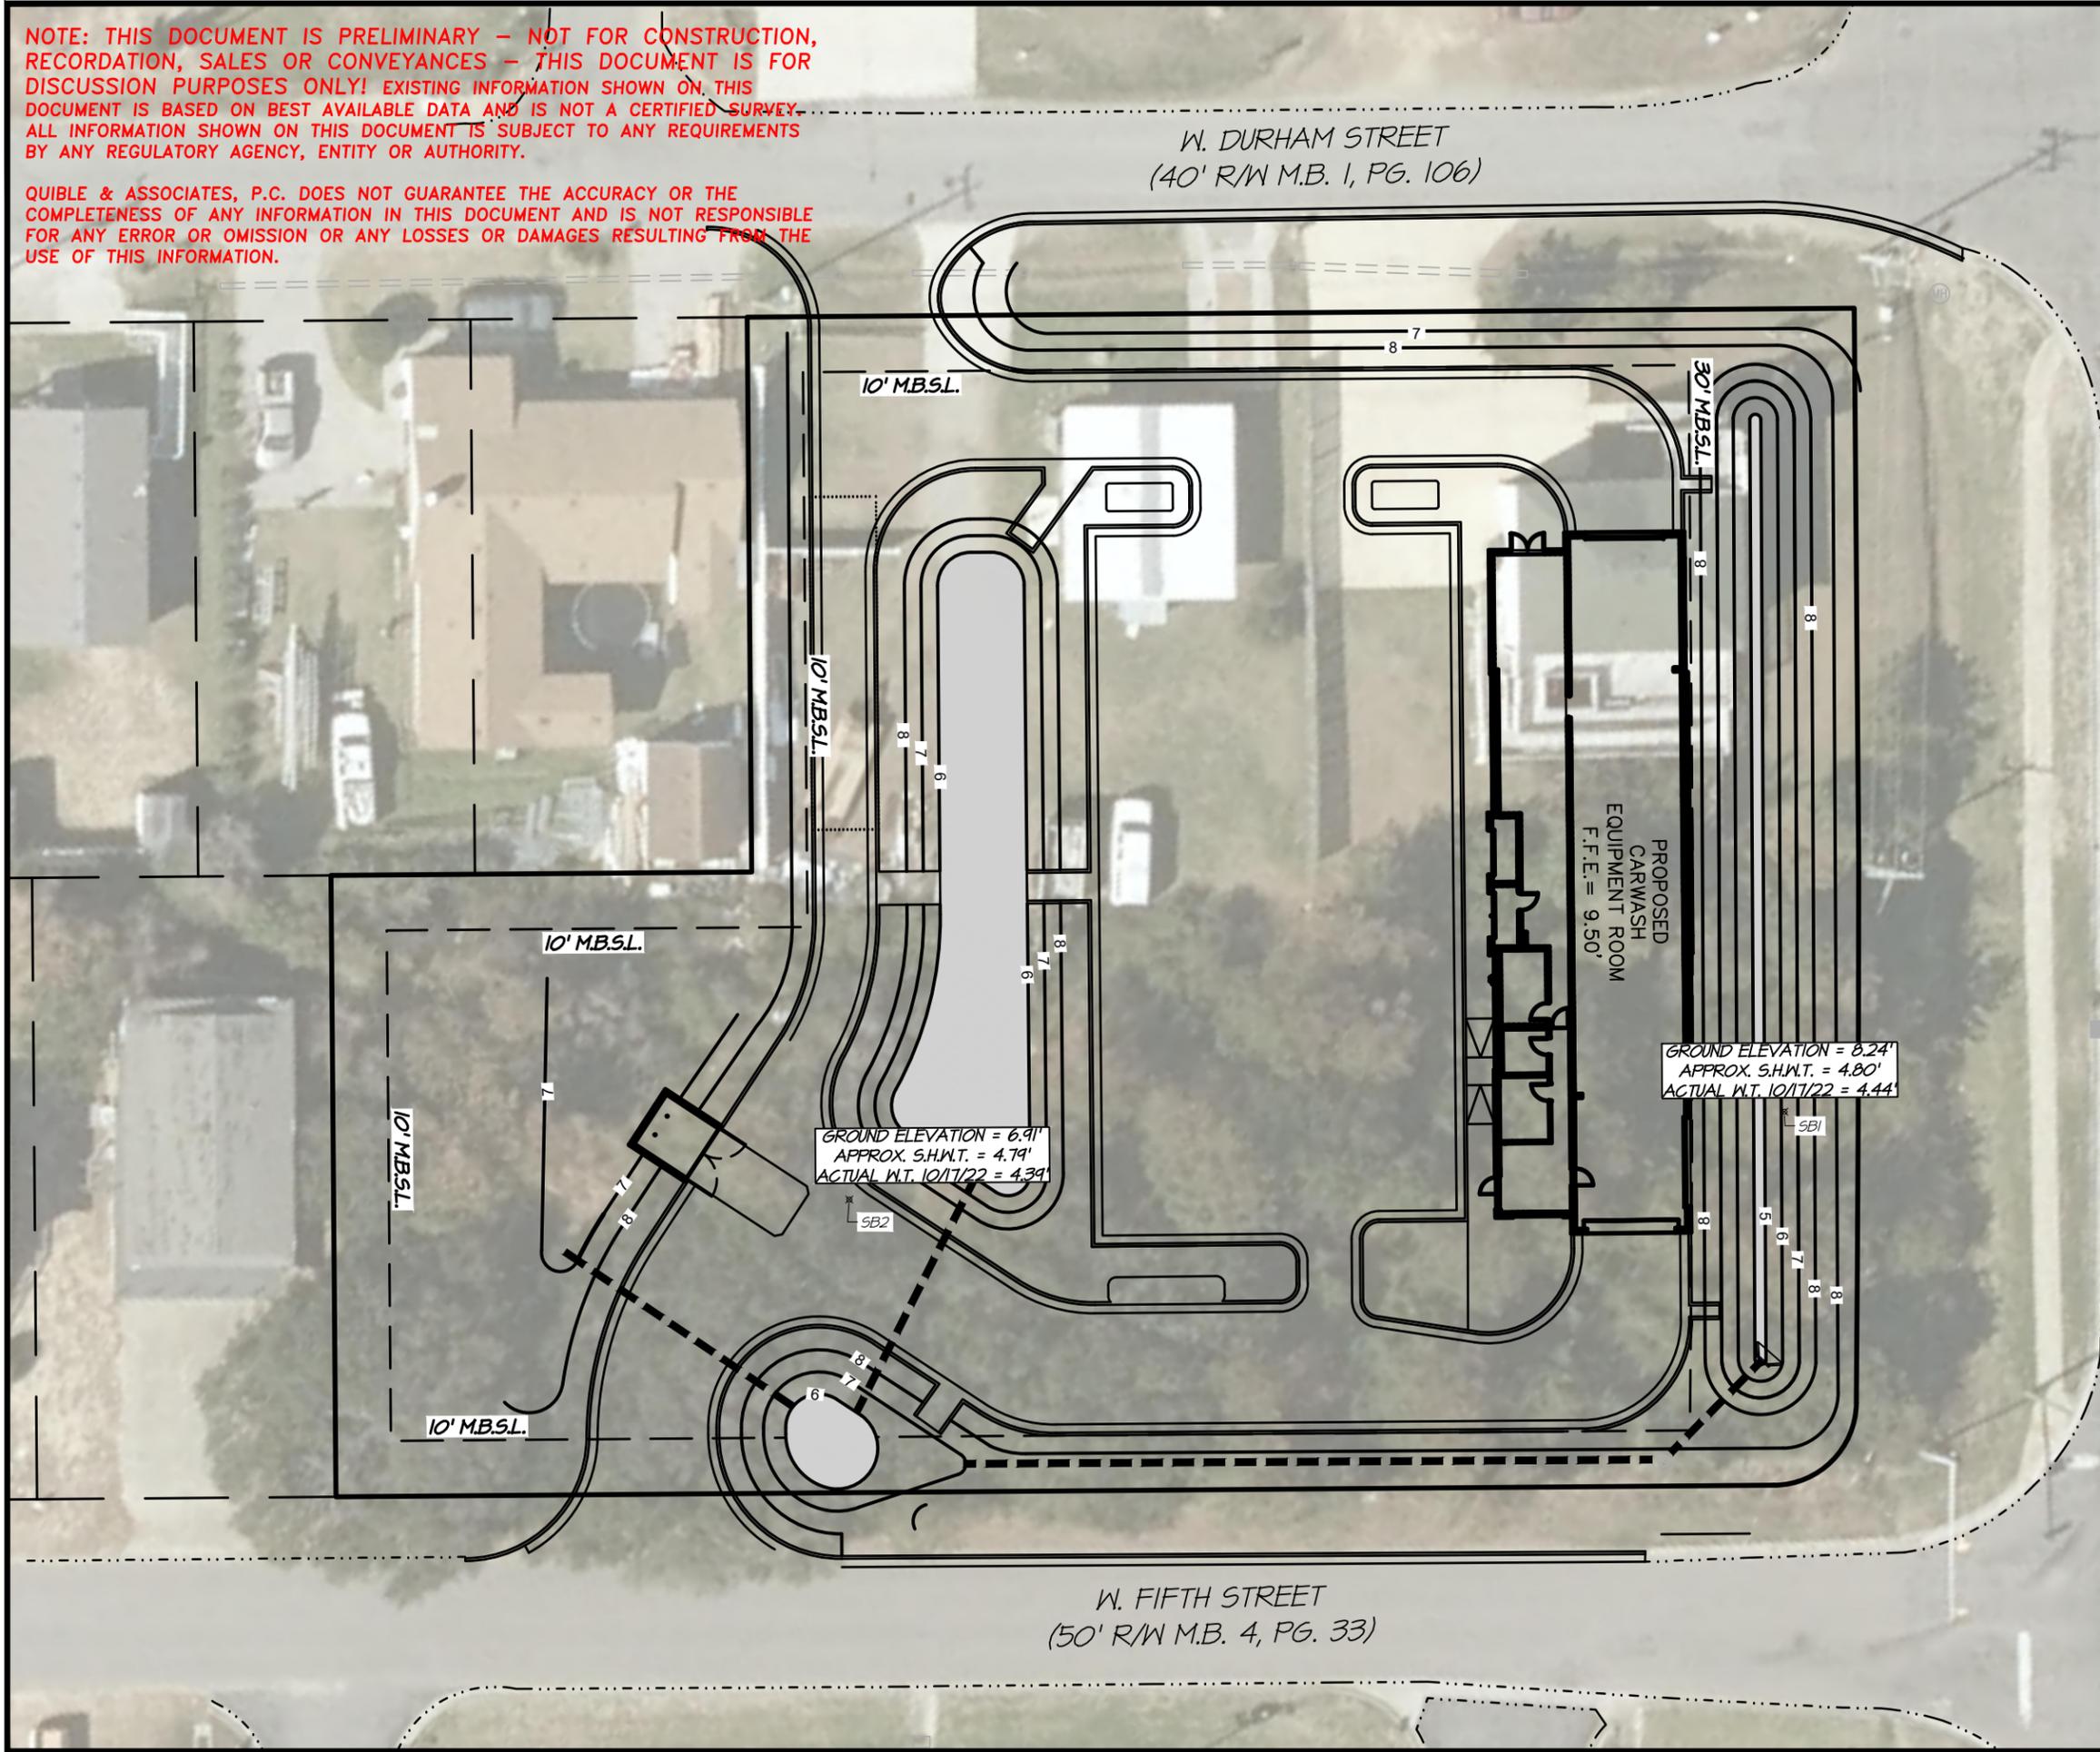
On Monday October 17, 2022, representatives from Quible visited the Site to conduct shallow soil borings in the location of potential future stormwater collection basins or infiltration areas. The purpose of our evaluation was to understand lithologic conditions, to determine the depth and elevation of the Static Water Table (WT), Season High Water Table (SHWT), and to measure infiltration rates for a Stormwater Management System design for a car wash facility. We selected two locations (SB-1 and SB-2) for our testing as shown on the accompanying exhibit.

Soil Boring	Ground Elevation (ft); (NAVD 88)	Groundwater Elevation (ft); (NAVD 88)	Approx. Elevation of SHWT (ft); (NAVD 88)	Measured infiltration Rates (in/hr.)
SB-1	6.91'	4.39'	4.79'	>20
SB-2	8.24	4.44'	4.80'	>20
